# Friends of Scotchmans Creek and Valley Reserve Inc

Waterwatch Report 27 April 2025

## Scope

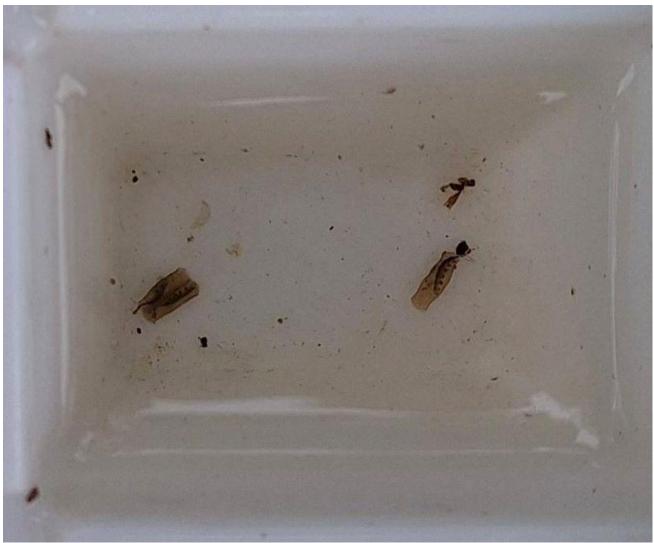
- The water quality measurements are mostly Fair to Excellent, except for Poor or Degraded turbidity at 3 of the 4 sites. The cause of poor turbidity at site 1b (upstream site) is not obvious. Turbidity at site 2 (downstream) is probably from works on the adjacent retarding dam. The turbidity at site 3 (Valley Creek) is probably from recent dredging work in Valley Reserve.
- The invertebrate sample ratings at the upstream sites were both Poor. The loose sand in the creek beds has moved recently. At site 1a (Scotchmans Creek, upstream) there are new holes to beware of, and more aquatic vegetation which improves the areas that can be swept with the net. We found many caddisfly larvae (hydrotilidae, micro caddis), which are found in all water bodies but are hard to spot because of their tiny size and translucent silk cases (photo below).

micro caddis at site 1a - in the ice-cube tray (photo ML, cropped)
